1969 Corvette: Service News: Anti-Reversing and Telltale Odometers

Subject: Anti-Reversing and Telltale Odometers

Model and Year: 1969 Vehicles

Source: Chevrolet Service News

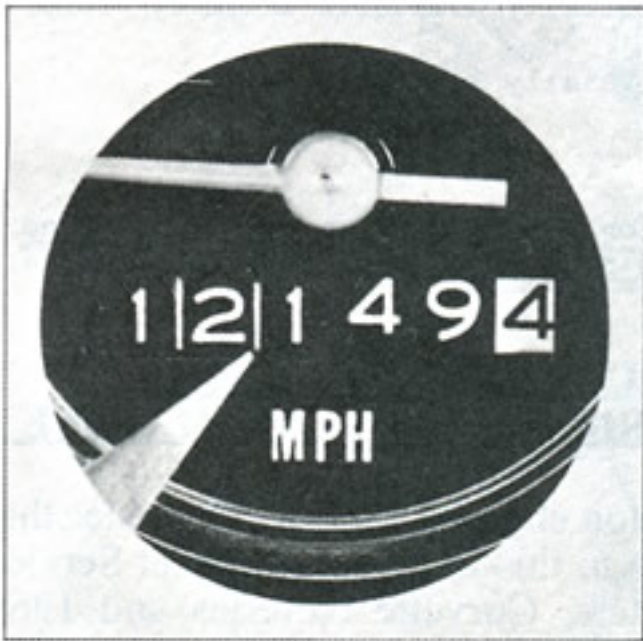
Fig. 40—Anti-Reversing Odometer

In addition to incorporating the anti-reversing feature, odometers used on vehicles built after January 1, 1969 also incorporate a telltale feature to provide visual evidence of any attempt to forcibly reset the mileage. If the first or second figure wheels of the pinion carriers are forced to rotate in an attempt to change the mileage reading, a white portion of these pinion carriers is exposed as shown in Figure 40. This color change from black to white occurs due to the fact that forcing the odometer wheels or pinion carriers will break a plastic 'carrier breakaway strip', which holds the carriers in alignment.

Breaking this strip allows the first and second carriers to rotate, exposing the white surface.

As stated in an article entitled "Anti-Reversing Odometers - 1969 Vehicles", which appeared in the February, 1969 issue of Chevrolet Service News, the anti-reversing odometers will ordinarily be to accumulate mileage after forward motion of 0.2 mile or less. Under some conditions, however, additional forward motion will be required and therefore, an odometer should not be considered non-functional until a minimum of five (5.0) miles has been covered in a forward direction.

What was not stated in this article was the fact that if a vehicle equipped with the anti-reversing odometer is driven in reverse or operated on test equipment in reverse for a distance of one-quarter (1/4) of a mile or more, the special cam and gear assembly between the odometer drive wheel and the decimal wheel will disengage and the odometer will cease to function. In order to restore operation, then, the vehicle must be driven in a forward direction for a distance of up to five (5.0) miles.
