2014 - 2015 Corvette: Service News: Rough Idle or Vibration

Subject: Rough Idle or Vibration

Model and Year: 2014 - 2015 Corvette with RPO LT1 Engine

Source: Chevrolet Service News

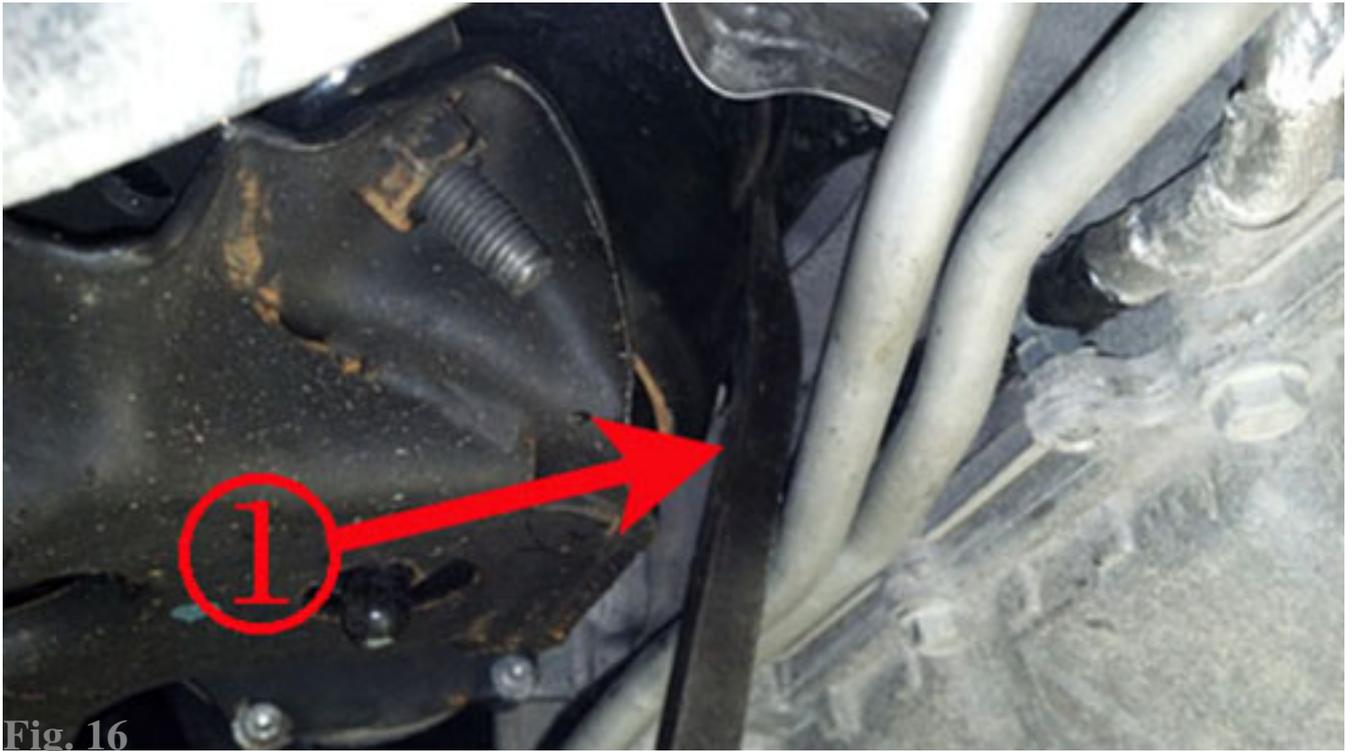
Fig. 16

2. Lift the engine slightly to take the load off the mounts.
3. Use a pry bar to push the mount outboard as far as possible (about 1–1.5 mm) (Fig. 16, left engine mount; Fig. 17, right engine mount); torque the bolts while pushing the mount outboard.
