2014 - 2015 Corvette: Service News: Rough Idle or Vibration

Subject: Rough Idle or Vibration

Model and Year: 2014 - 2015 Corvette with RPO LT1 Engine

Date: October 8, 2014

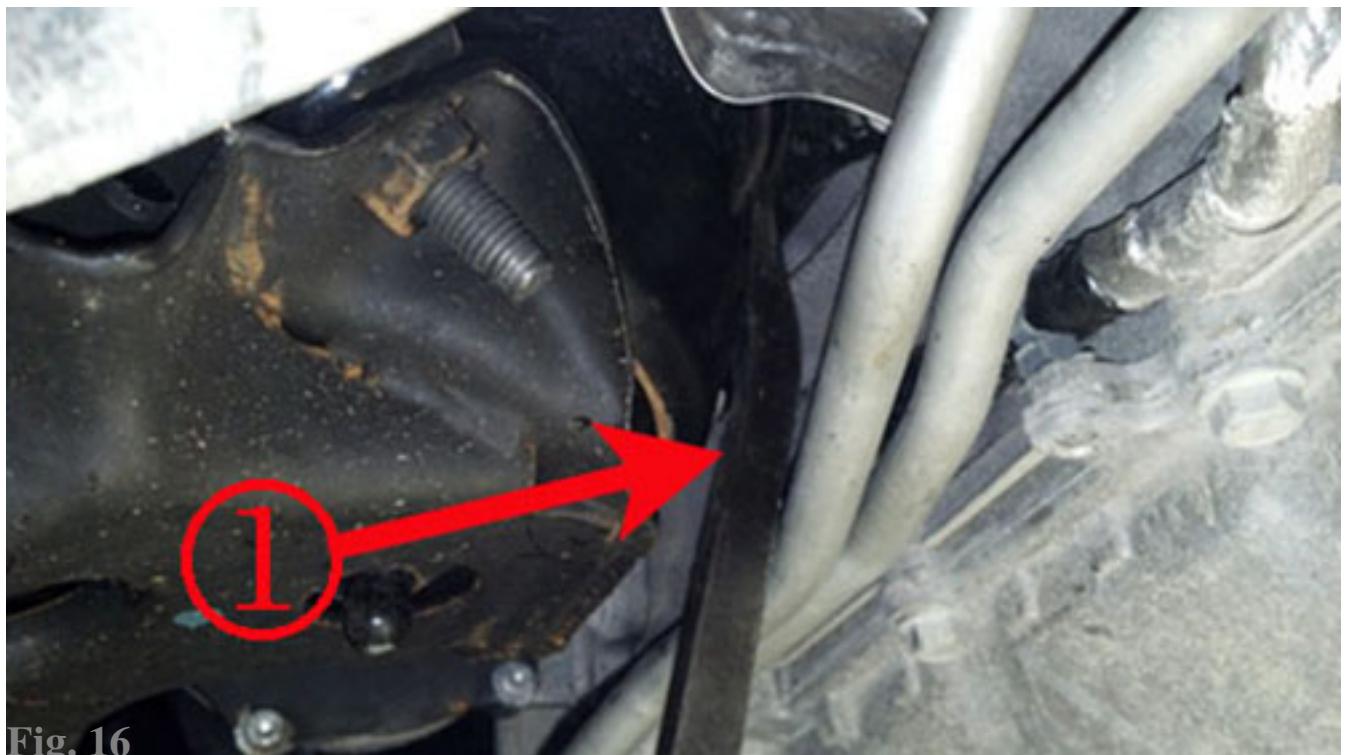
Fig. 16

2. Lift the engine slightly to take the load off the mounts.
3. Use a pry bar to push the mount outboard as far as possible (about 1–1.5 mm) (Fig. 16, left engine mount; Fig. 17, right engine mount); torque the bolts while pushing the mount outboard.
