1968 Corvette: Service Bulletin: Gas Line Rattle

Source: Chevrolet Dealer Service Information Bulletin - General Motors Canada

Bulletin No: 68-IC-54

Date: June 29, 1968

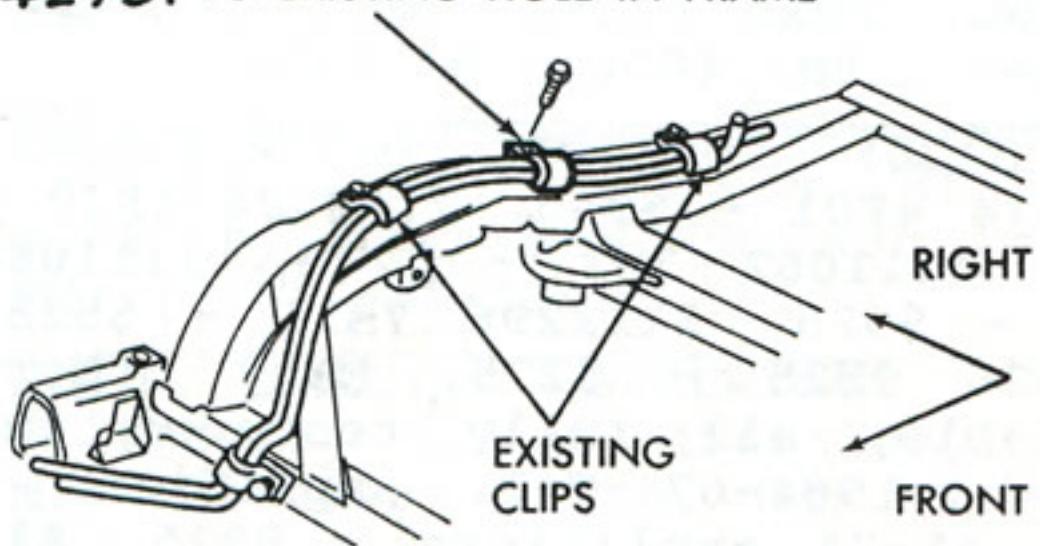
A rattling or "ticking" noise from the rear of the vehicle has been experienced on some 1968 Corvettes. This noise is resulting from the fuel supply line vibrating against the return line. Production has corrected this condition by installing an additional clip in the existing frame hole at this location. Refer to Fig. 1. This same correction is recommended for units in the Field that are experiencing the rattling or "ticking" noise. Fig. 1 illustrates where the clip should be added and gives the related parts data.

*ATTACH CLIP (3923695) WITH SCREW
442751 TO EXISTING HOLE IN FRAME
