2014 - 2015 Corvette: GM TechLink: Rough Idle or Vibration

Subject: Rough Idle or Vibration

Model and Year: 2014 - 2015 Corvette

Date: October 8, 2014

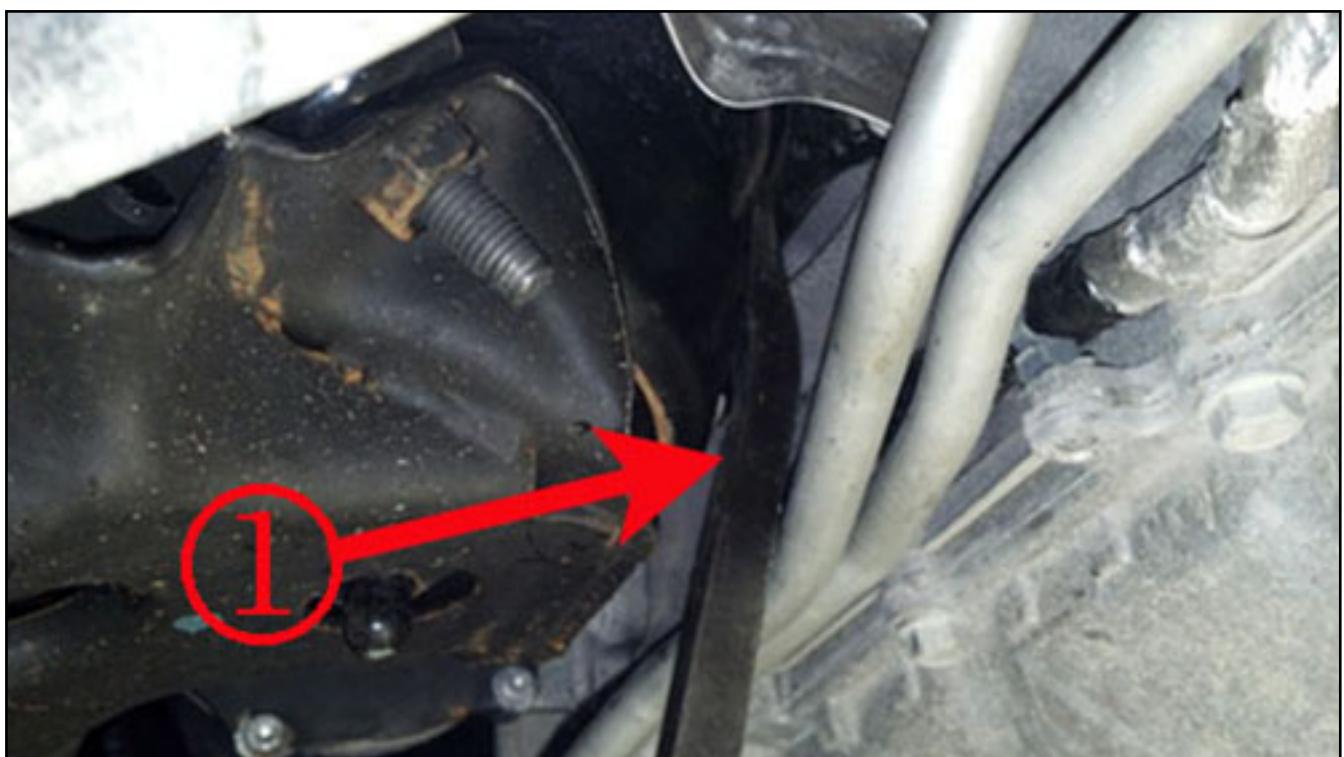
Fig 16

2. Lift the engine slightly to take the load off the mounts.
3. Use a pry bar to push the mount outboard as far as possible (about 1–1.5 mm) (Fig. 16, left engine mount; Fig. 17, right engine mount); torque the bolts while pushing the mount outboard.
